# **Selected Images of the Effects of the October 15, 2006, Kīholo Bay-Māhukona, Hawai‘i, Earthquakes and Recovery Efforts**

Data Series 506

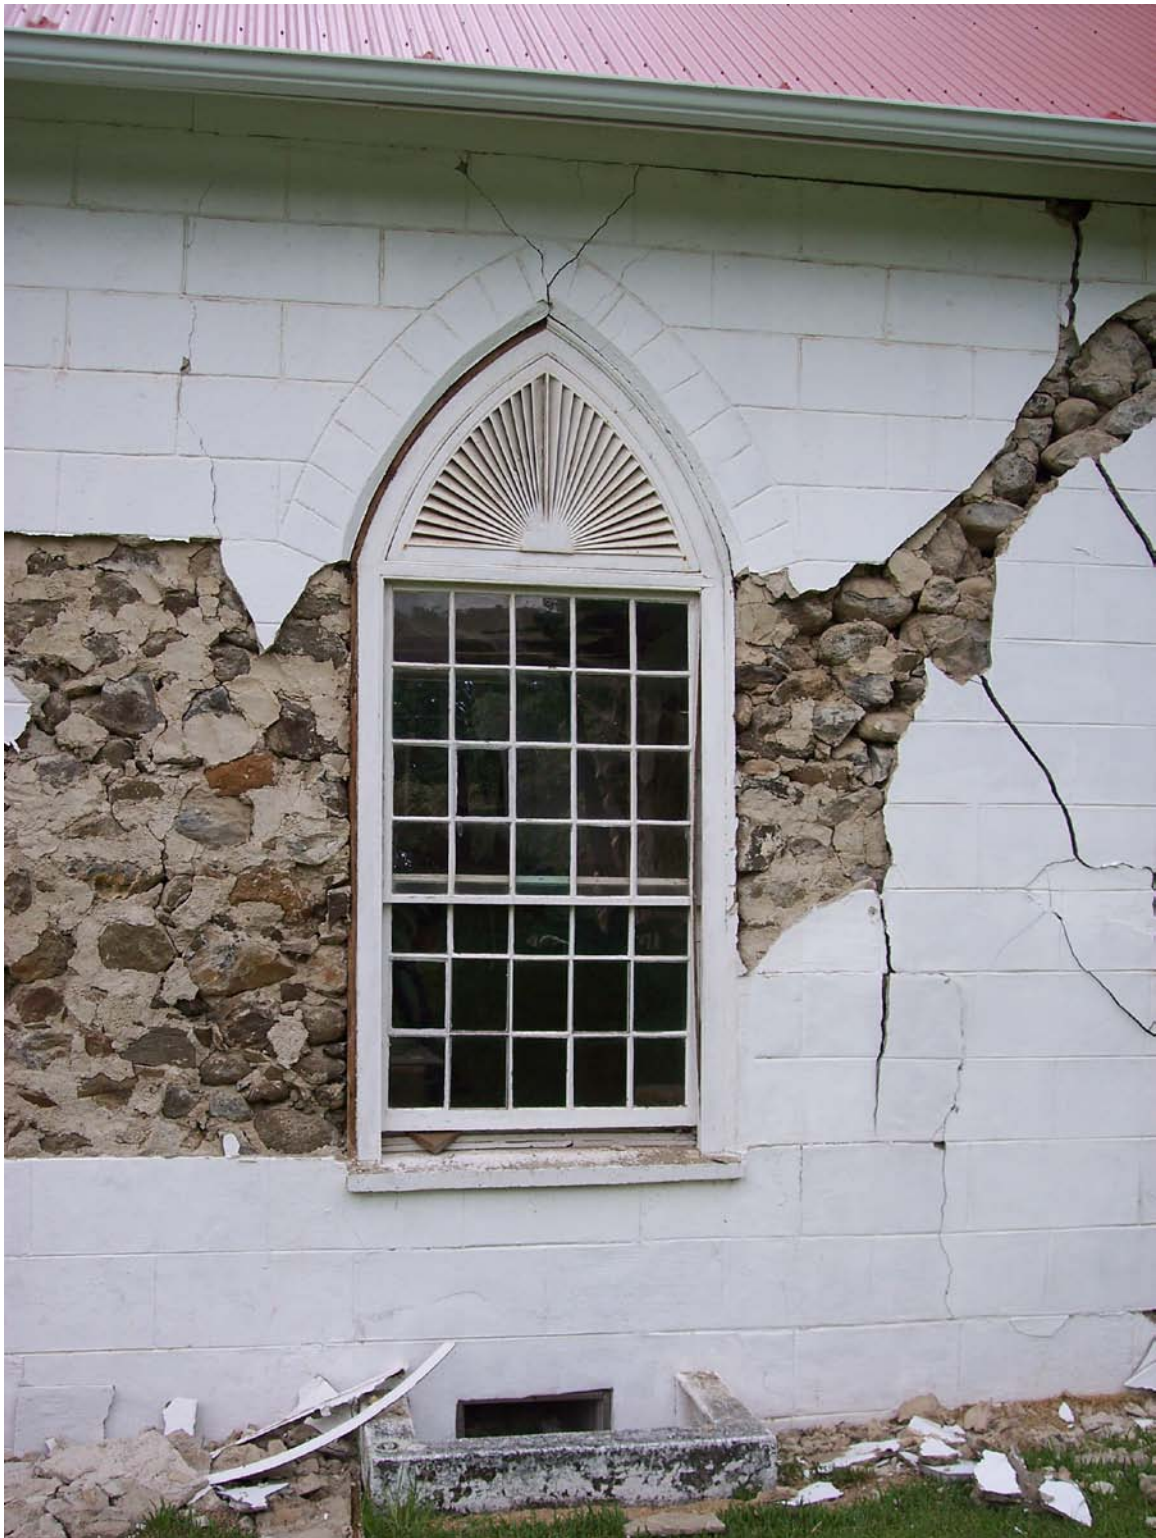
24.14. Detail of cracks in the stucco, showing the crumbling mortared stone wall at the southeast corner of the church (view to the north-northeast). The sunburst pattern at the top of the window frame, repeated in the design of the bell tower, reflects the meaning of “Kalāhikiola” (“the life-bringing sun”). USGS photo by T.J. Takahashi, 10/20/2006 (tjt1380).

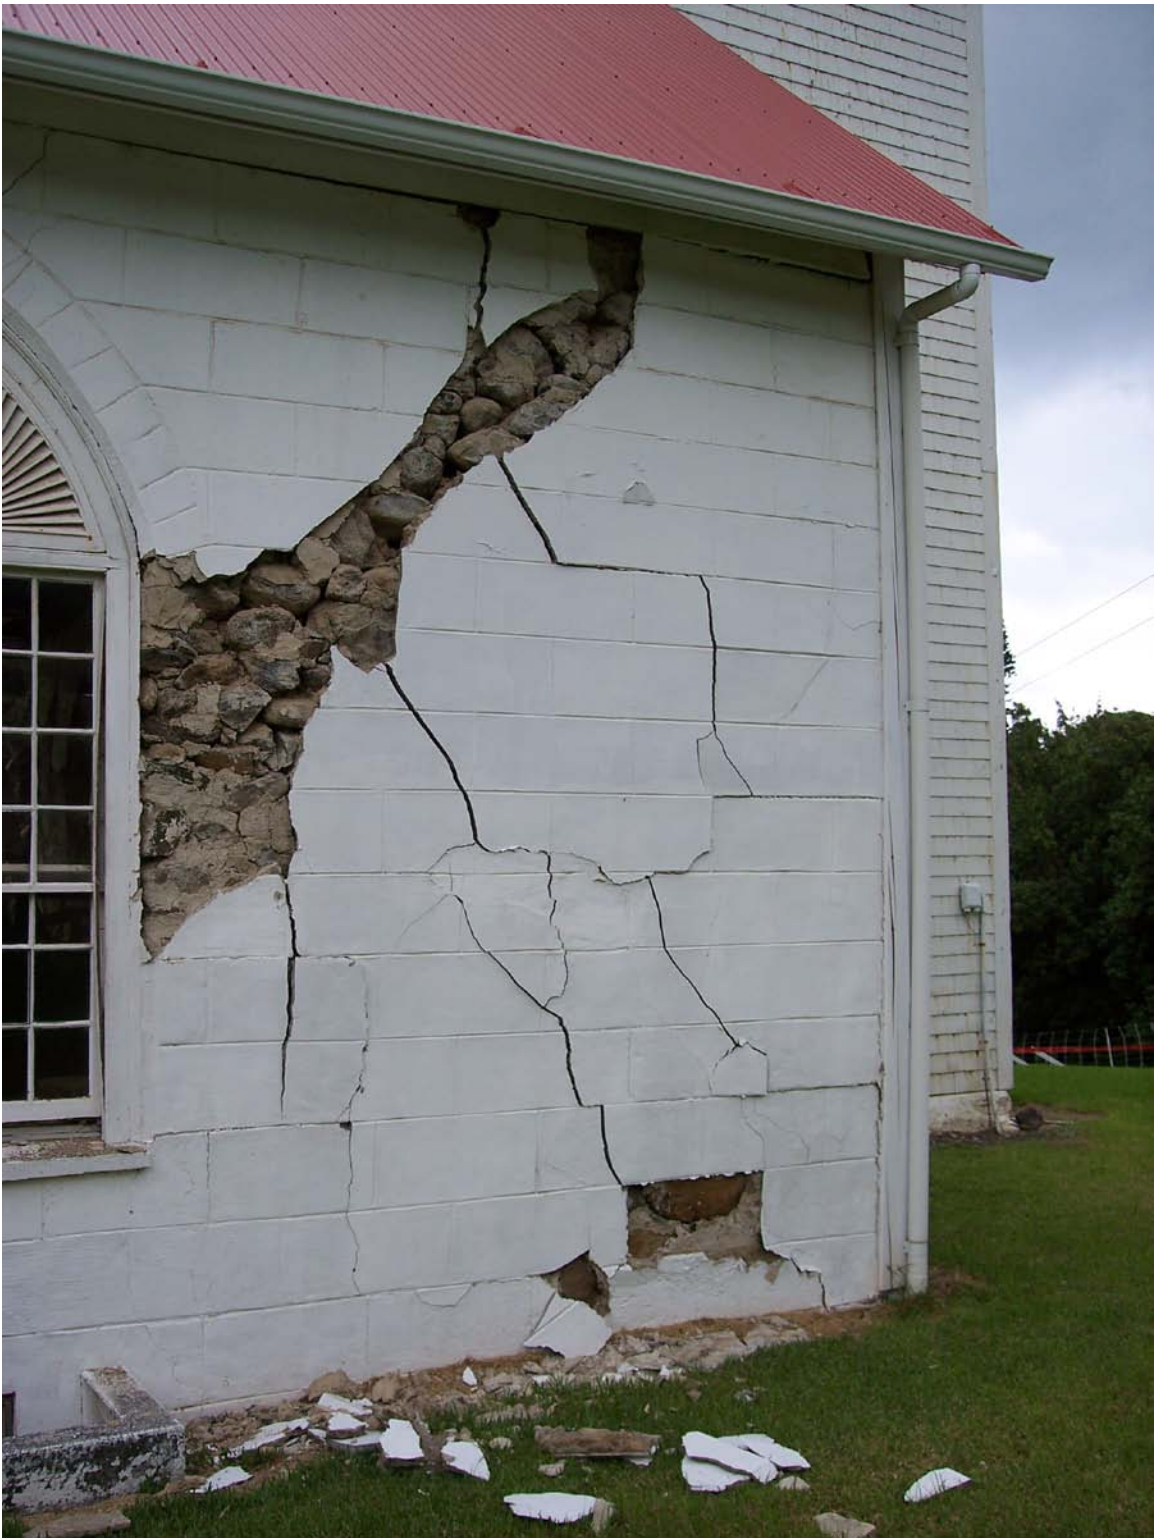
24.15. View of the end of the wall at the southeast corner, showing the pattern of cracking in the exterior stucco. Note lines incised into the stucco to resemble building blocks (view to the northeast). USGS photo by T.J. Takahashi, 10/20/2006 (tjt1379).

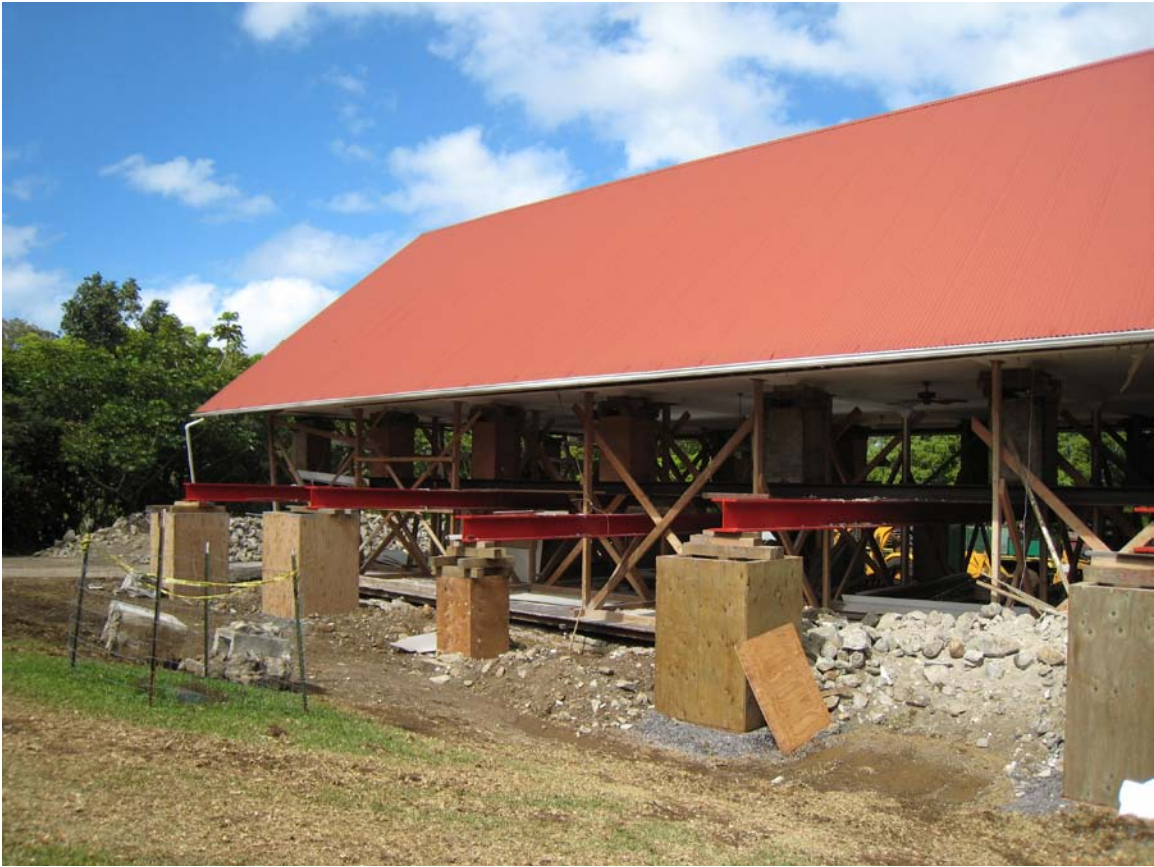
24.19. View of the support pillars that insured structural stability while the church underwent extensive repairs. The ceiling and roof nearly collapsed from the effects of the earthquake. Water pooled on the floor as a result of ground subsidence from a succession of earthquakes over time, culminating in the effects of the October 15, 2006, earthquake. The floor was raised to prevent damage from moisture and provide elastic movement during earthquakes (B. Bond, oral commun., 1/17/09) (view to the northwest). USGS photo by T.J. Takahashi, 1/17/2009 (tjt973).

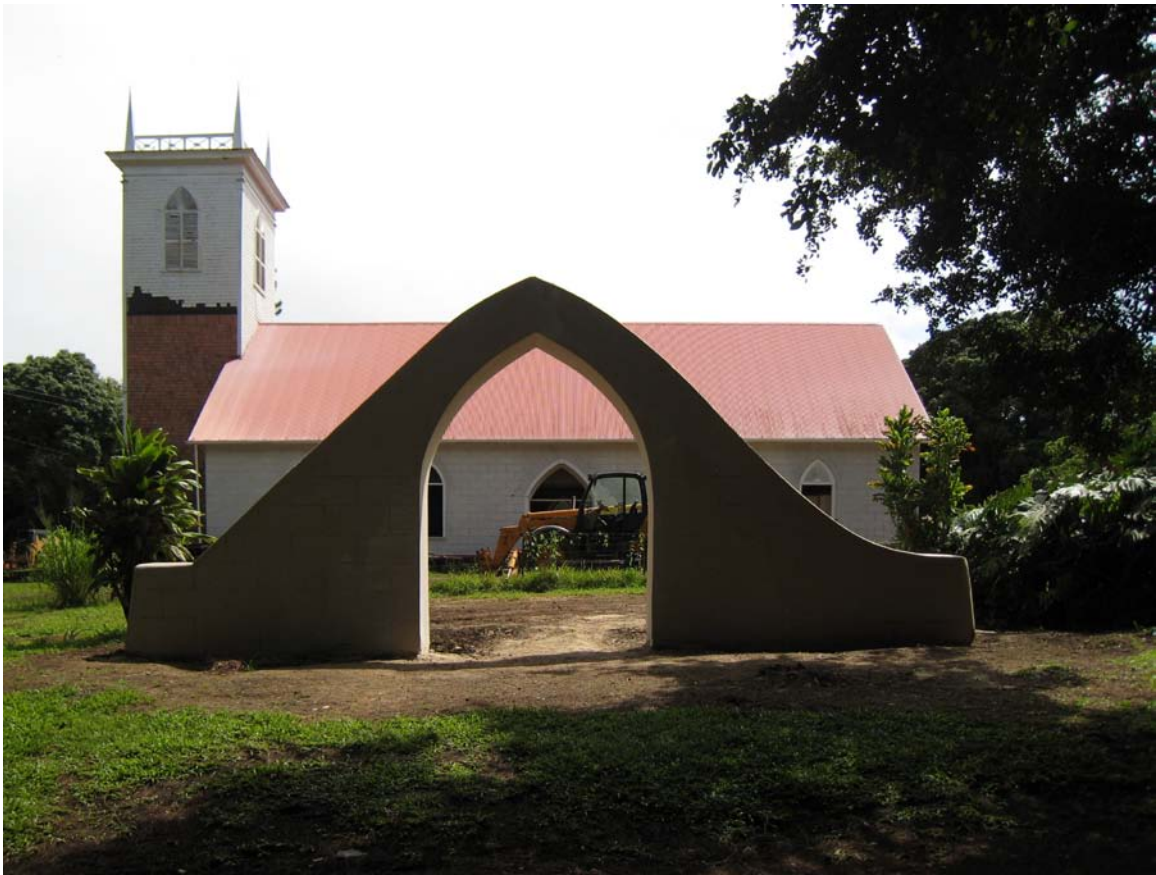
24.21. View of the steel-reinforced concrete archway, rebuilt after the original one collapsed during the earthquake. Repairs are also in progress on the lower-to-middle section of the bell tower (view to the south). USGS photo by T.J. Takahashi, 9/5/2009 (tjt1463).

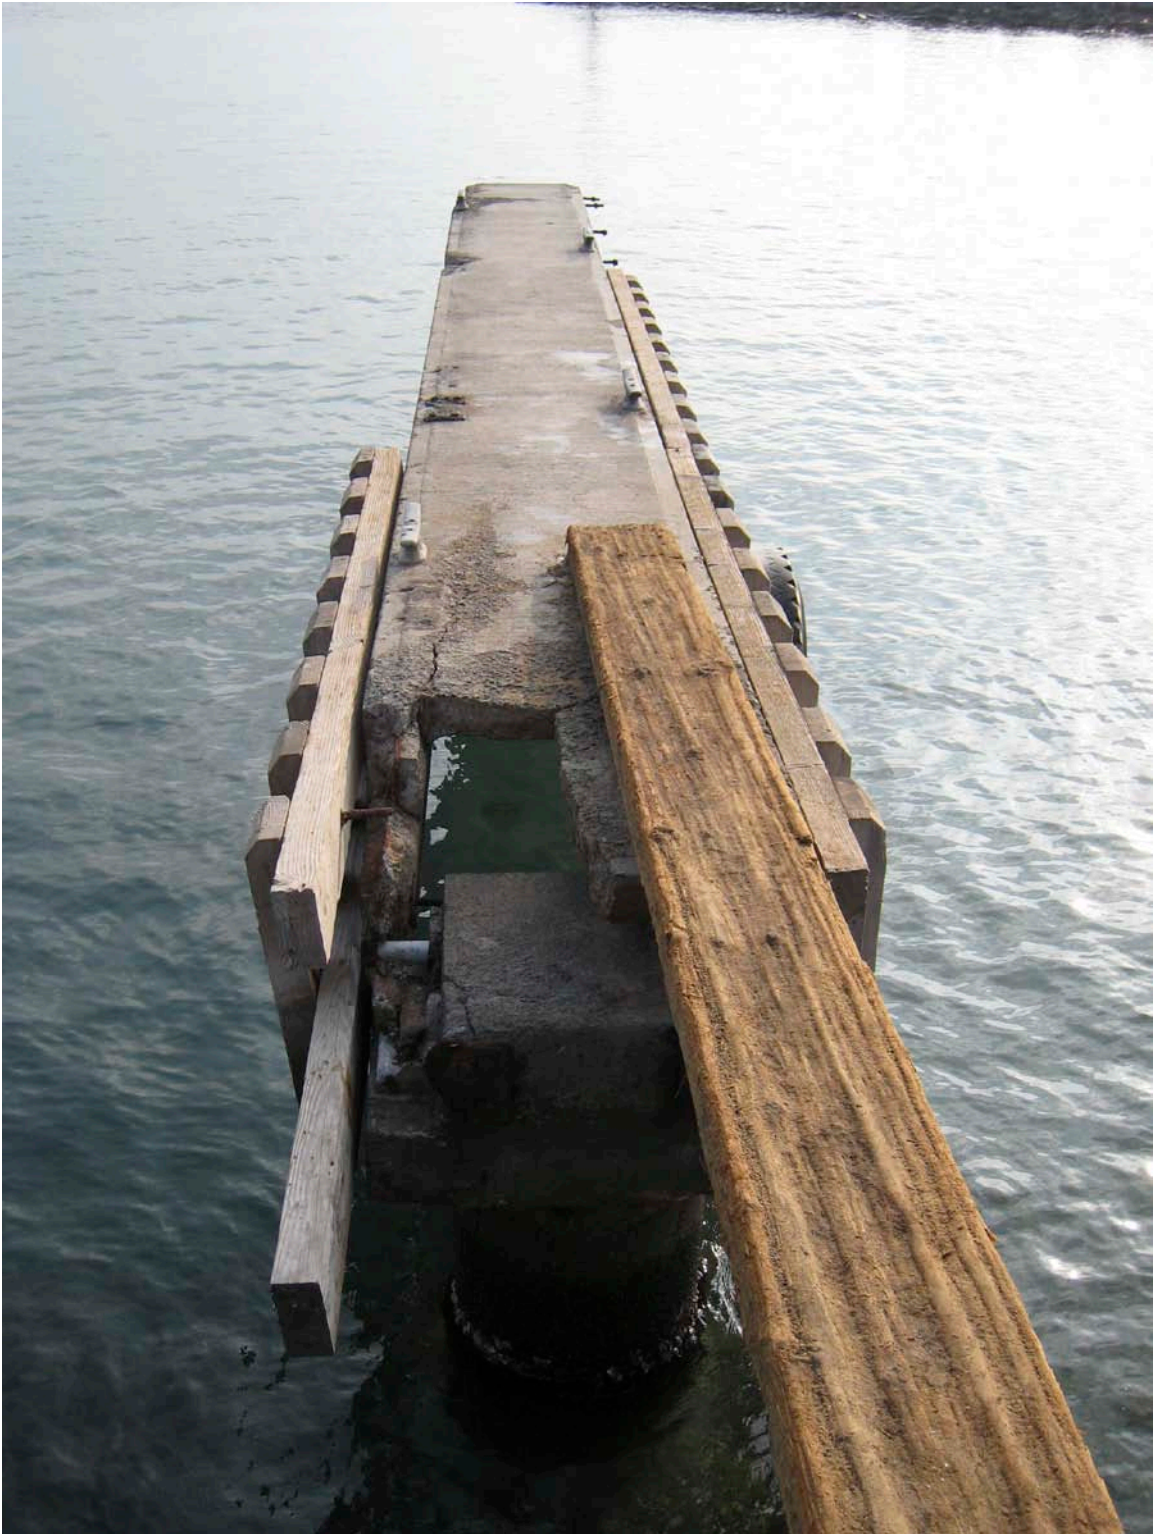
28.4. View of the plank to Loading Dock Number 2 that bypasses the hole created in the concrete slab as a result of the earthquake (view to the south-southwest). USGS photo by T.J. Takahashi, 11/28/2008 (tjt736).

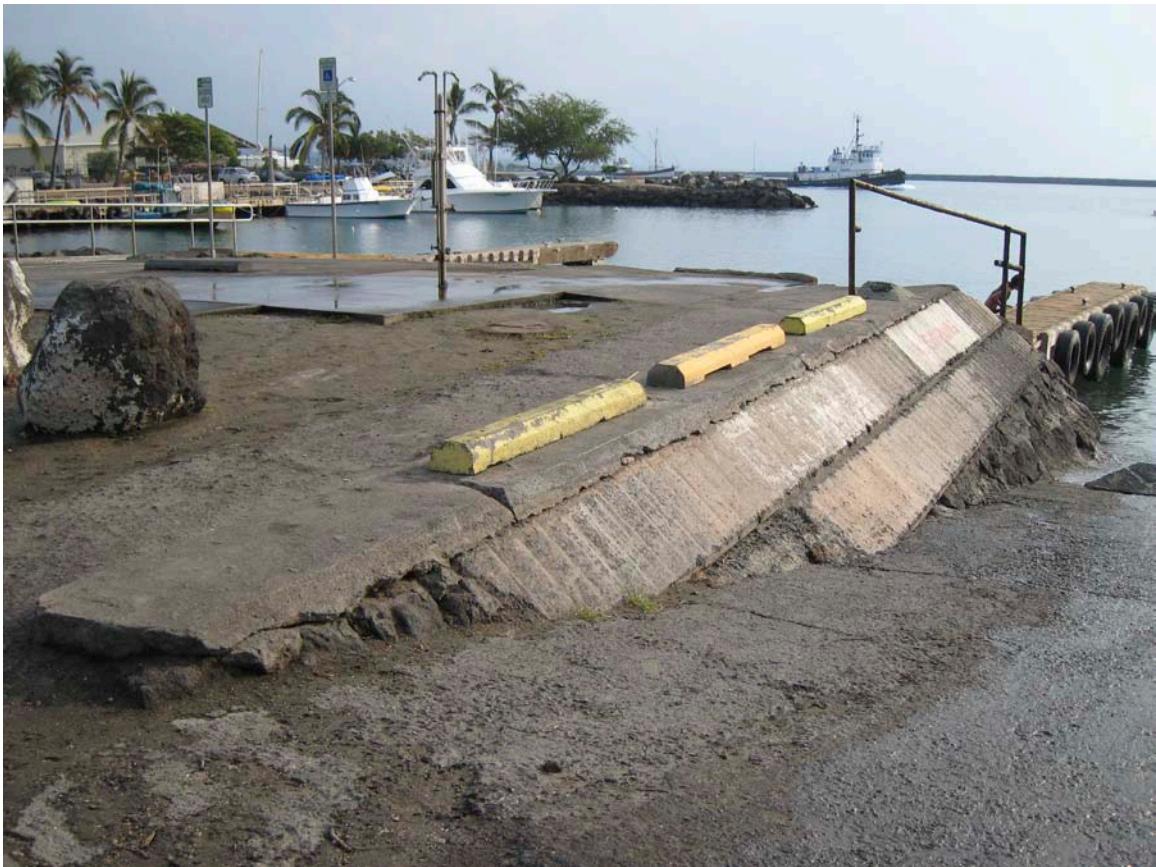
28.5. View of the numerous cracks that opened up in the pavement at the boat-launching ramp (view to the south). USGS photo by T.J. Takahashi, 11/28/2008 (tjt721).

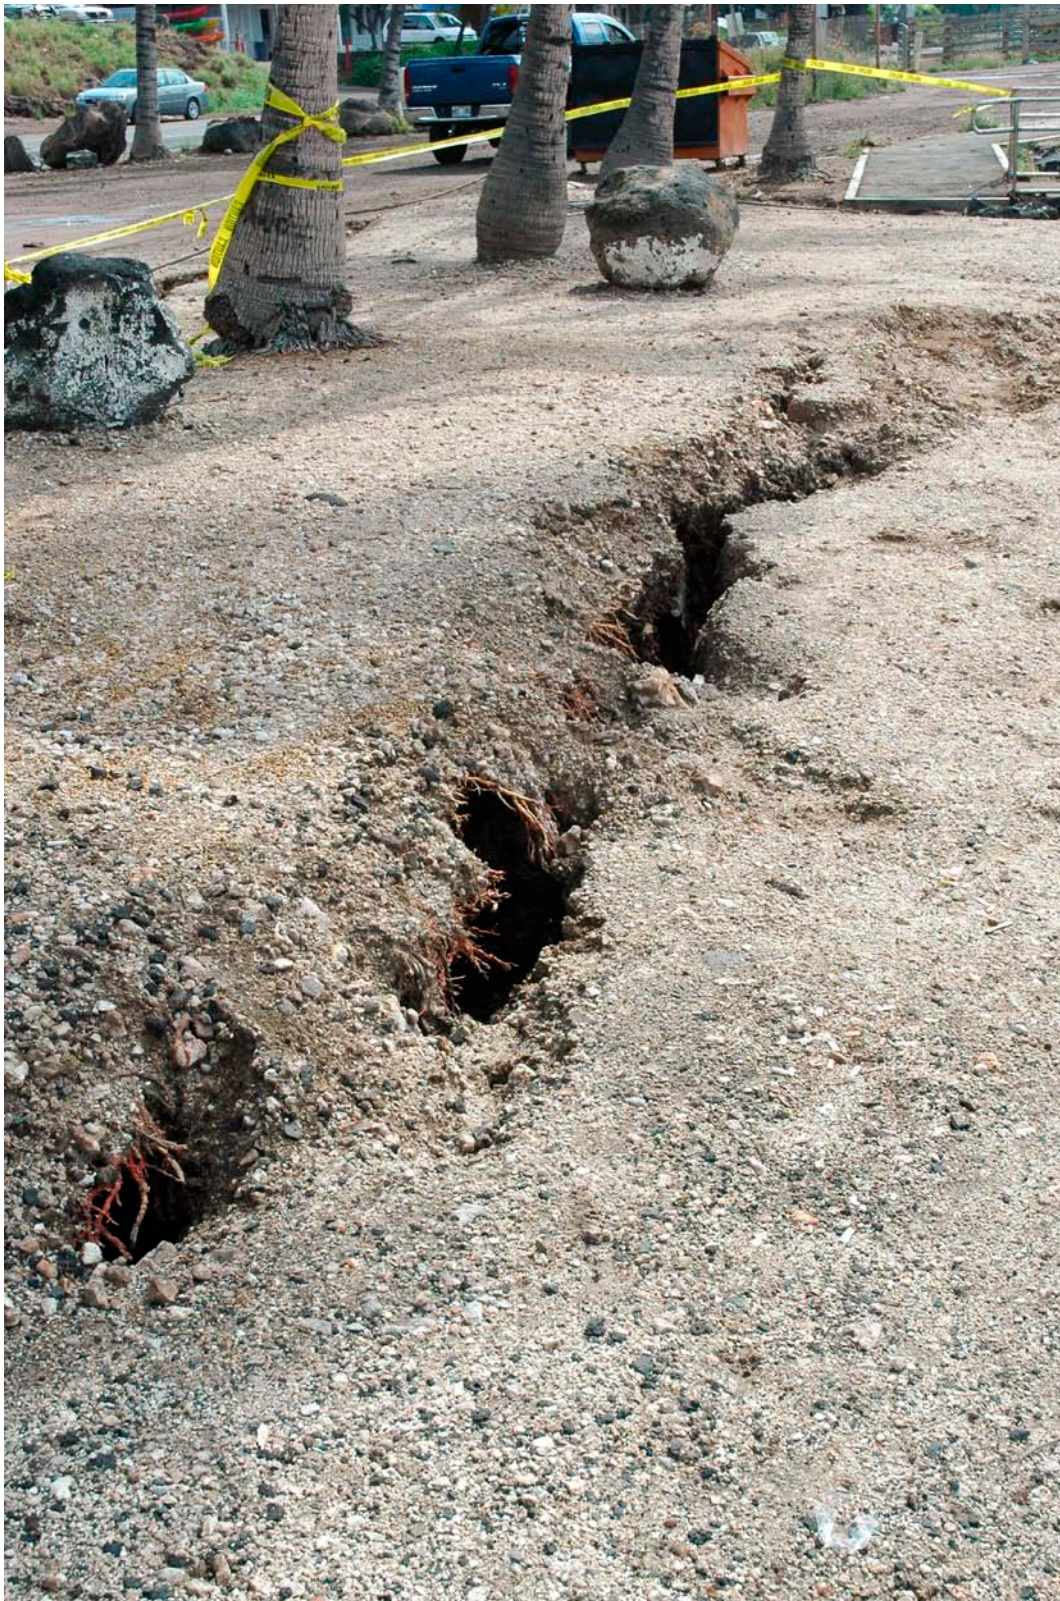
28.6. View of lateral spreading and slumping of the ground parallel to the seawall at North Kawaihae Small Boat Harbor. The crack, which grew between the seawall and the parking lot, extends along the entire length of the seawall (view to the southeast). The area was yellow-tagged, allowing restricted use. CSAV photo by D.A. Whilldin, 10/25/2006 (daw064).

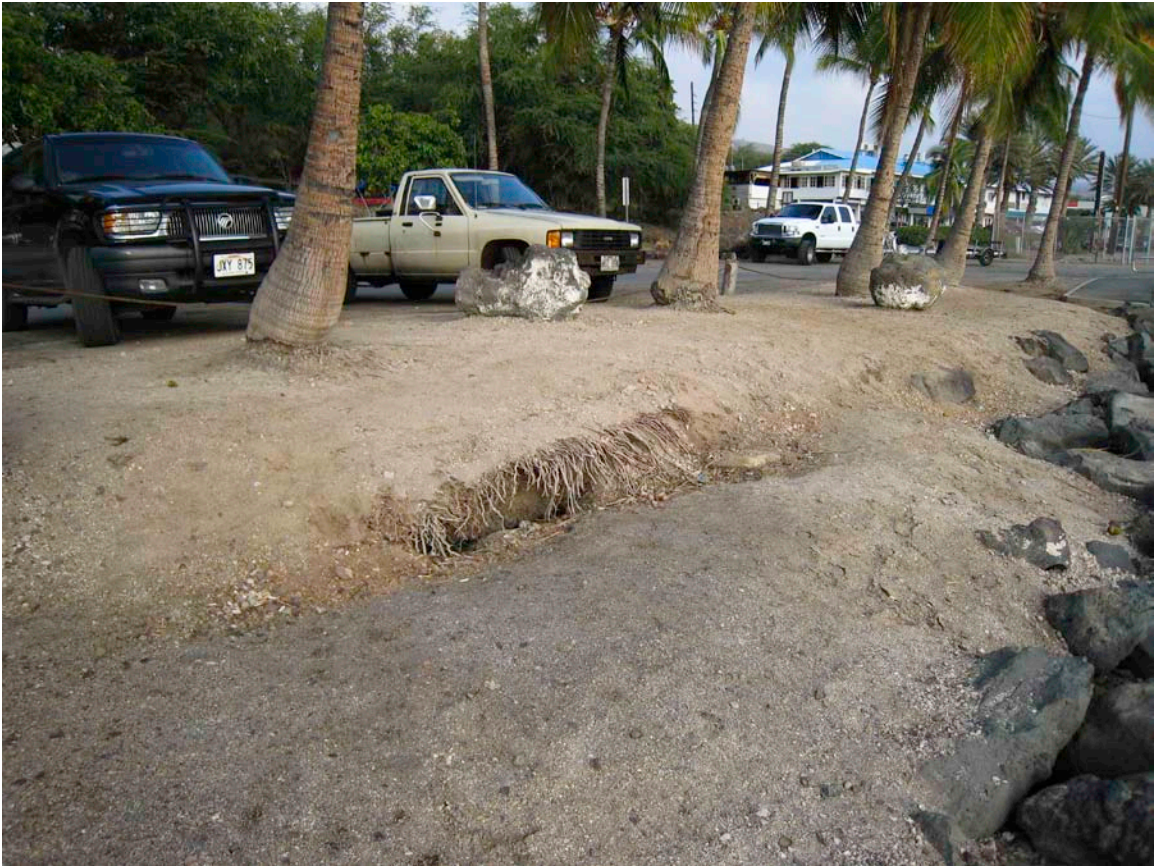
28.7. View of slumping of the shoreline behind the rock revetment wall, exposing coconut tree roots and rocks under the sand-filled ground cracks (view to the east). USGS photo by T.J. Takahashi, 11/28/2008 (tjt740).

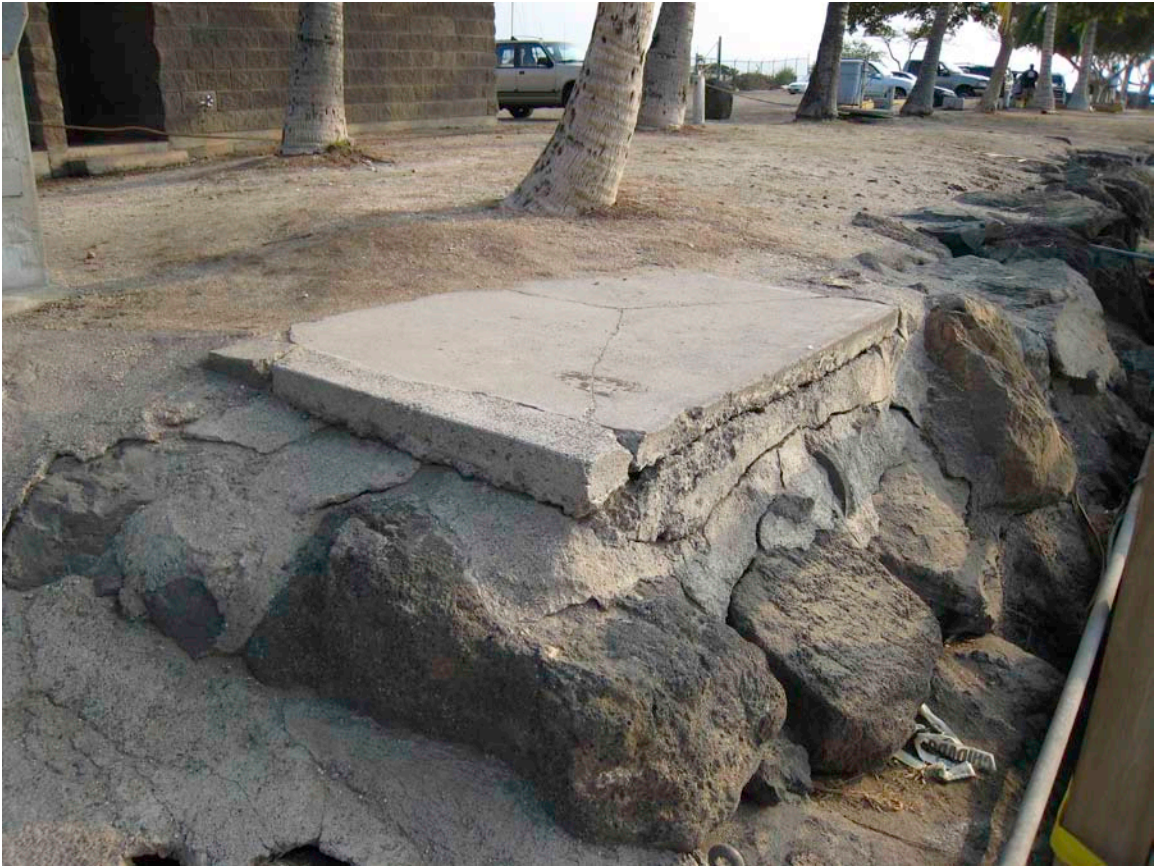
28.9. View of the cracked concrete slab and mortar beside the walkway ramp leading to the wharf's platform (view to the southeast). USGS photo by T.J. Takahashi, 11/28/2008 (tjt760).

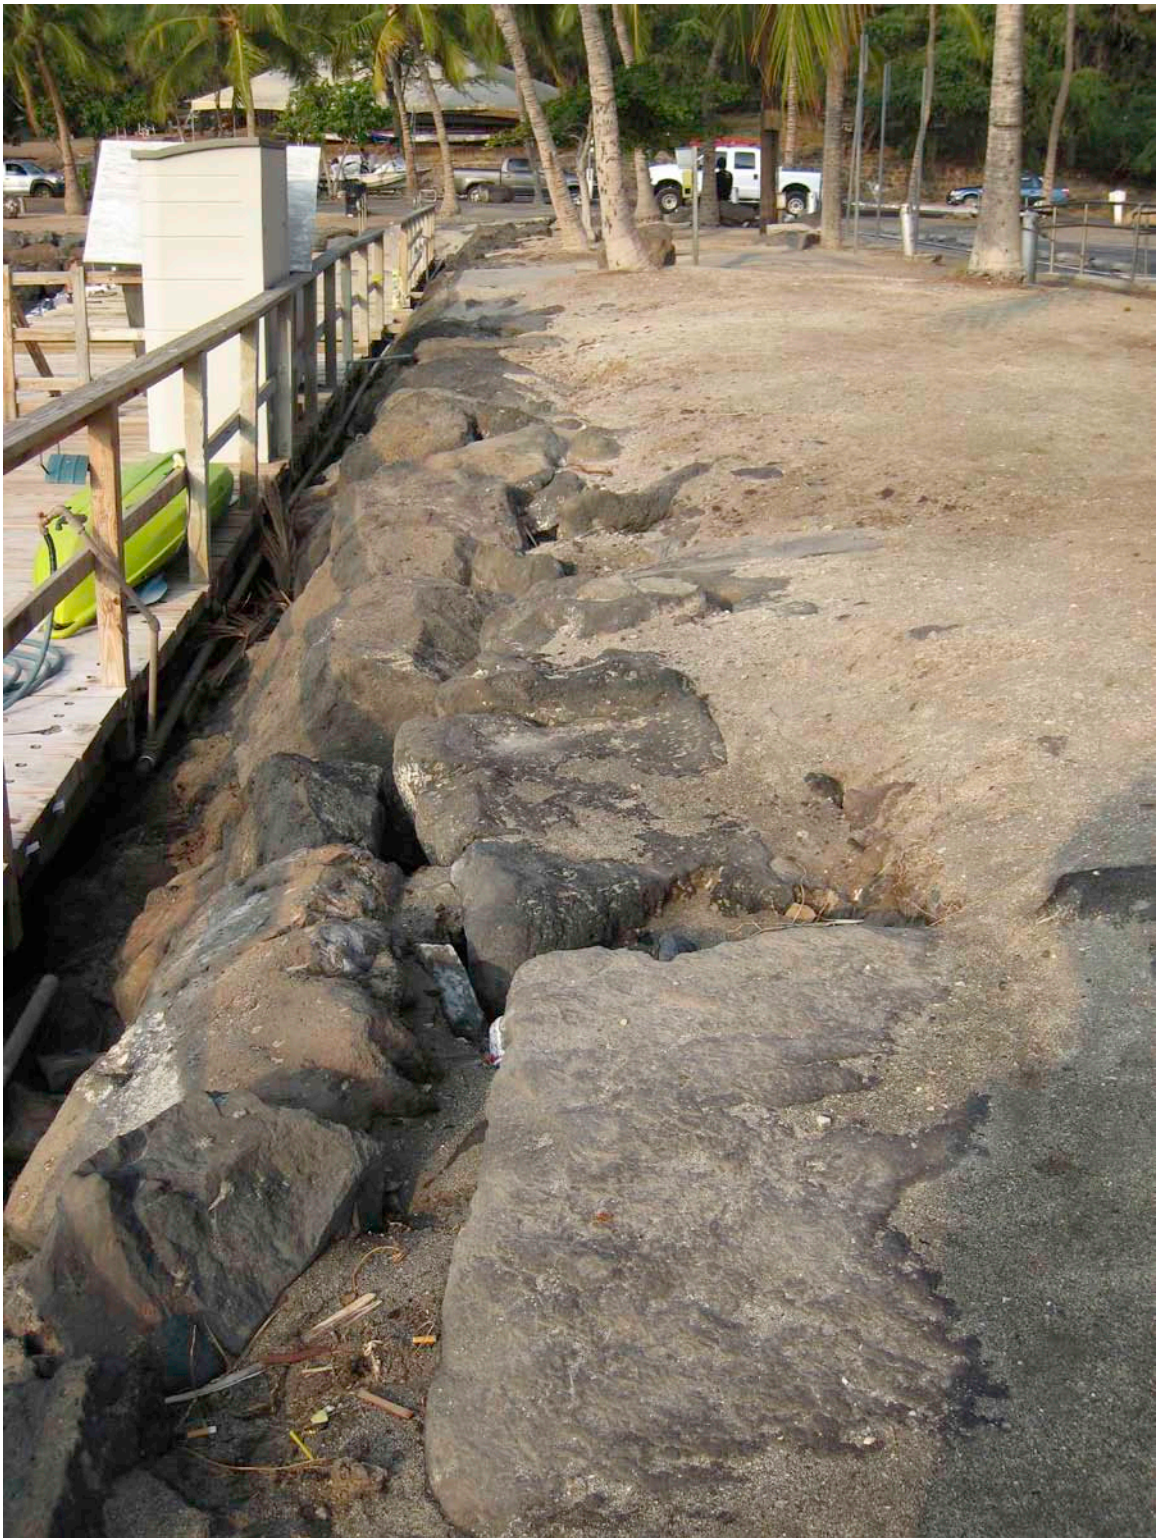
28.13. View of lateral displacement of boulders along the marginal wharf's platform (view to the north-northeast). USGS photo by T.J. Takahashi, 11/28/2008 (tjt771).

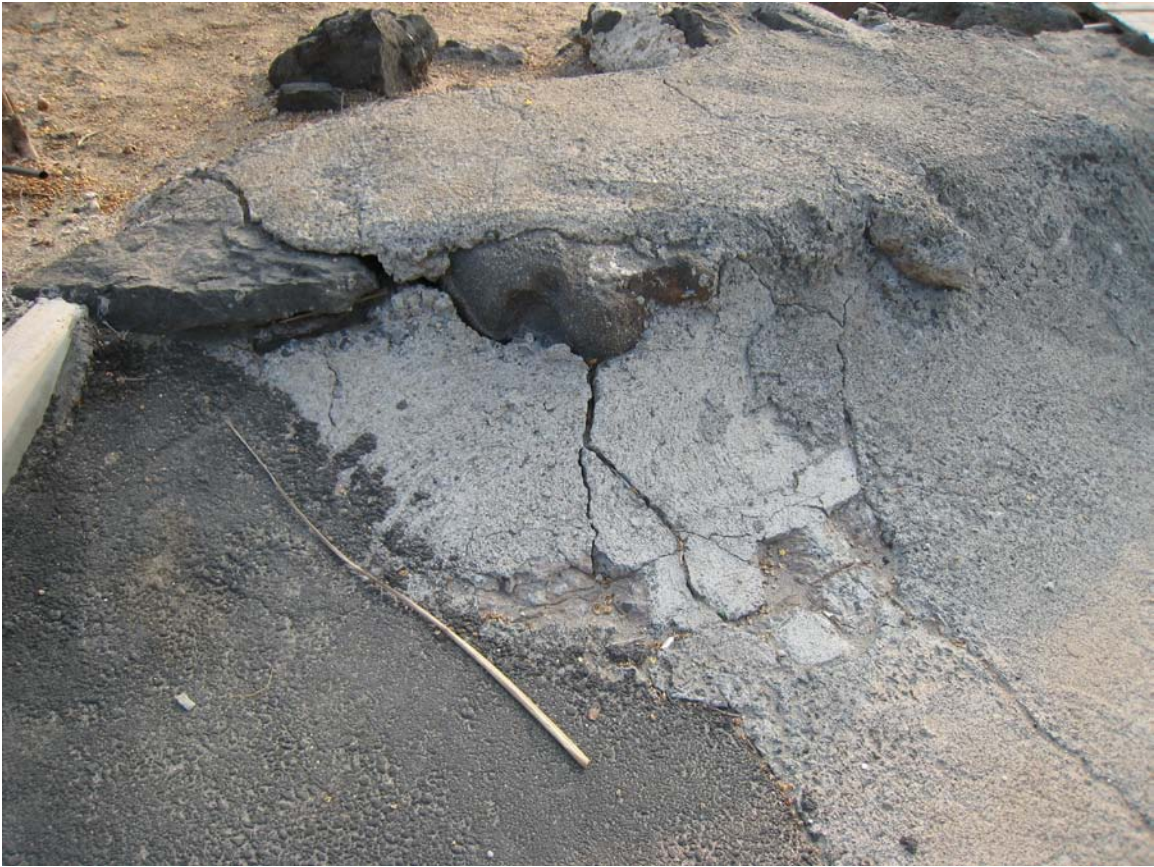
28.14. View of cracks in concrete, poured over rocks to stabilize the approach to the walkway at the marginal wharf (view to the south). USGS photo by T.J. Takahashi, 11/28/2008 (tjt819).

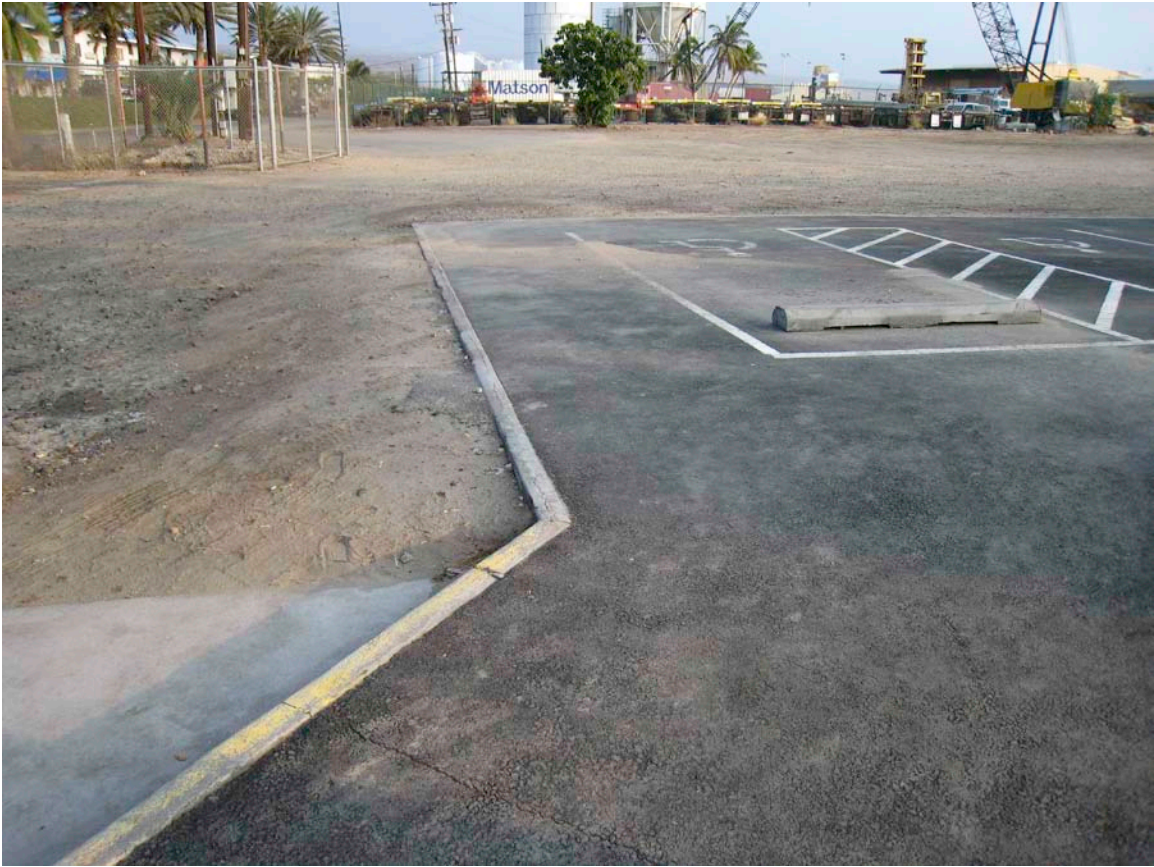
28.15. View of hairline fractures along the curb and through the asphalt pavement of the parking lot near the comfort station (view to the east-southeast). USGS photo by T.J. Takahashi, 11/28/2008 (tjt821).

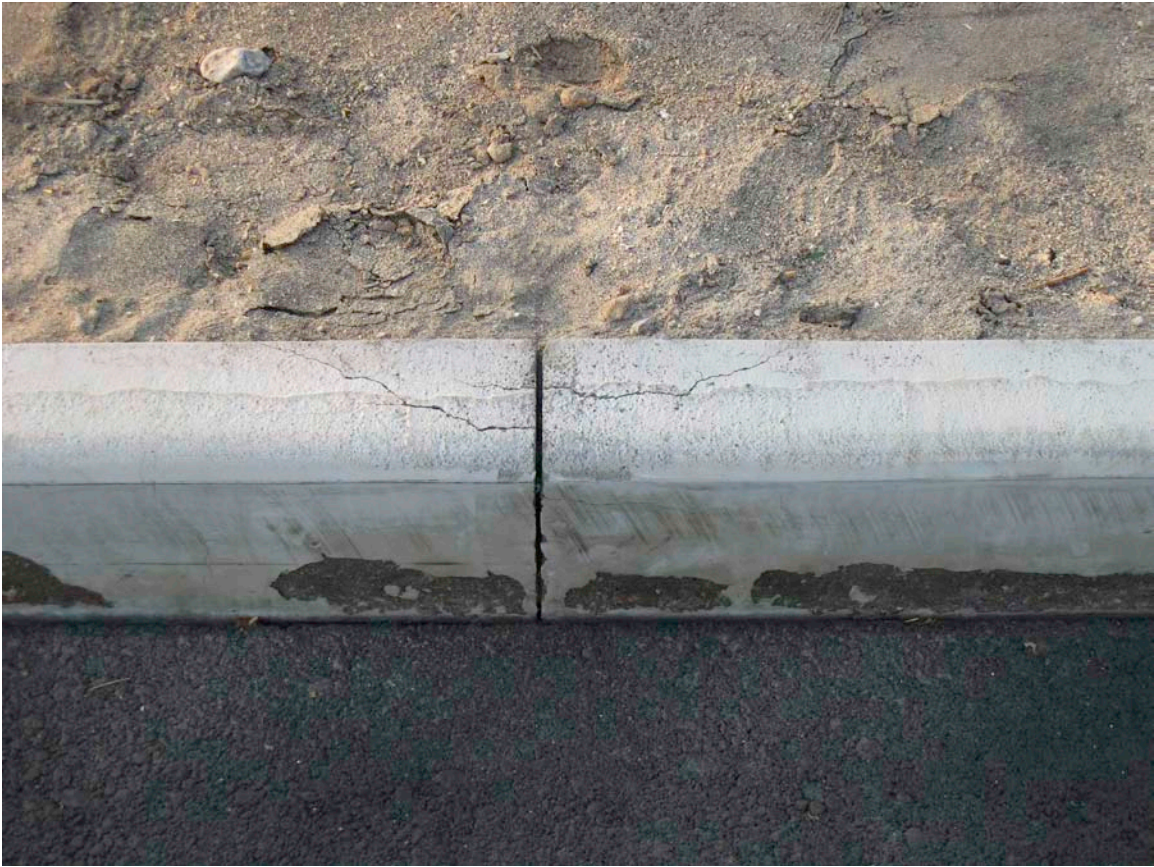
28.16. View of hairline fractures in the curb near the comfort station. USGS photo by T.J. Takahashi, 11/28/2008 (tjt824).

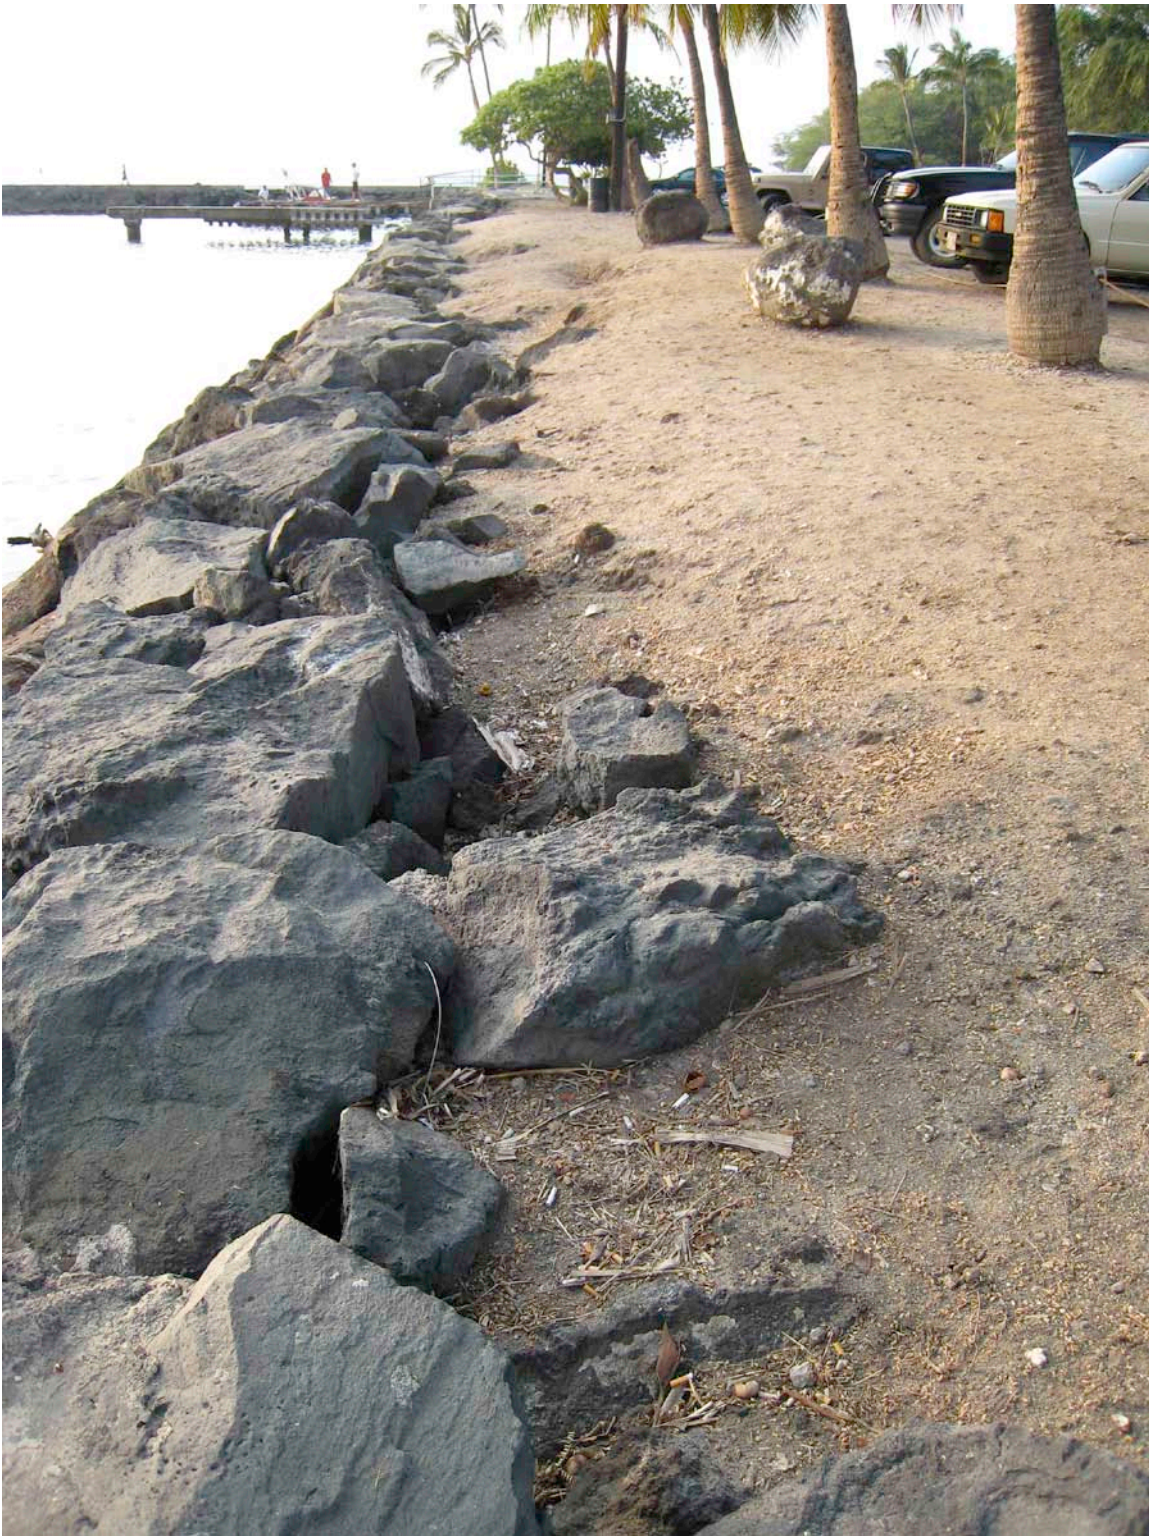
28.17. View of ground slumping and of rocks loosened by lateral displacement along the rock revetment seawall (view to the west-northwest). USGS photo by T.J. Takahashi, 11/28/2008 (tjt834).

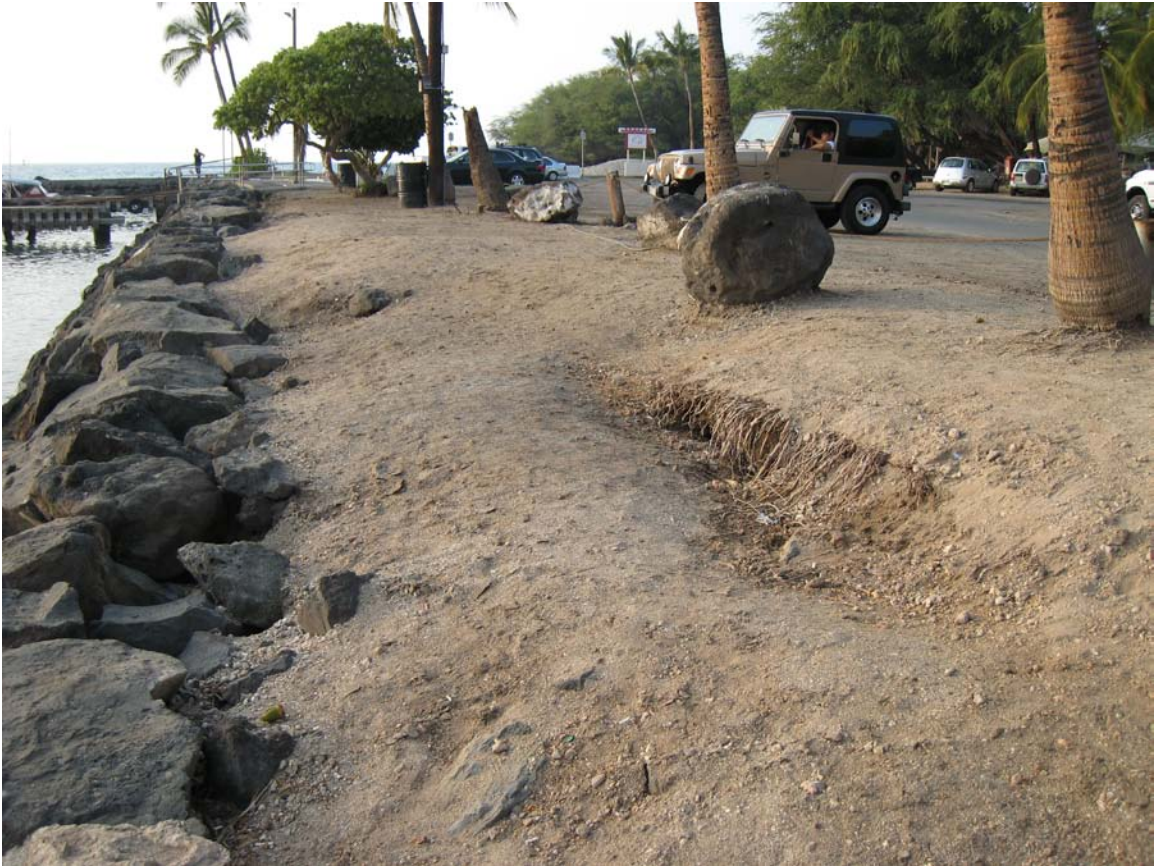
28.18. Close-up view of slumping and lateral displacement of the ground along the rock revetment seawall (view to the west-northwest). USGS photo by T.J. Takahashi, 11/28/2008 (tjt839).

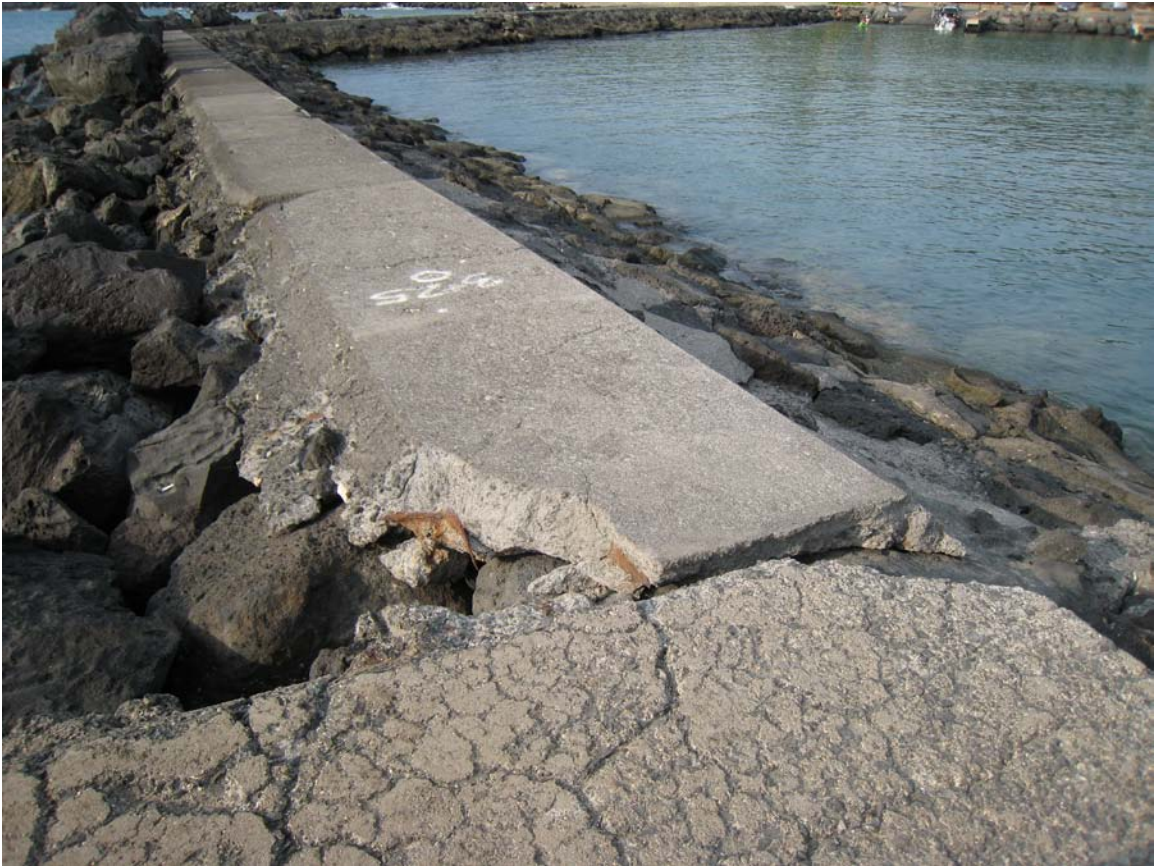
28.19. View of cracks in the concrete pavement over mortared rocks in the west-side breakwater of the harbor (view to the northwest). USGS photo by T.J. Takahashi, 11/28/2008 (tjt715).
